# Conversion of Wasted Land to Water Storage Tank and Its Utilization for Increasing the Crop Productivity in Malwa Region – A Case Study

Operational Research Project for Dryland Agriculture, RVSKVV Campus, College of Agriculture, Indore-452 001, Madhya Pradesh

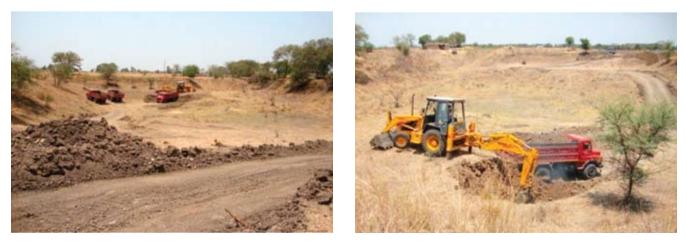
Shaping and deepening of excavated portion

Since this area was lying unused for almost 15 year, it was decided to use heavy machineries like JCB, dumpers and trolleys to provide it a regular shape and size like a water storage portion. The JCB excavated the irregular shaped portion and side slopes of 1:2 were maintained all around the tank area. This excavated soil was used by the farmer to fill up the depressed portion in his fields and the make area levelled. Even the neighboring farmers also paid for the excavated soil so that they can use it in their fields too for reclaiming the washes and shallow gullies. For this purpose the farmer paid ₹ 80,000/- for reshaping and leveling of this portion. On the other hand, he received almost 90,000/- from the neighbouring farmers in lieu of cost of excavated soil provided them to carry it to their cultivated fields. With the result, at almost no cost or expenditure incurred by the farmer to develop this area in to an excavated tank area of 85 m x 85 m x 10 m with a regular shape.

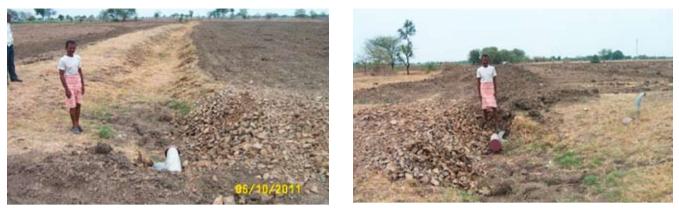
Installed underground pipeline with loose boulder structure in drainage line

of River Kshipra during entire monsoon season. Therefore, it was decided that the excess runoff from this drainage line is diverted towards the excavated tank area. Since the portion above the tank area belongs to another farmer, it was not possible to divert the excess runoff through an open excavated surface drain as it will pass through the cultivated area of other farmer making it fragmented and reducing a sizable portion cultivable. Provision of open drain may also a possible reason of conversion of this portion in to permanent gullies due to continuous and uncontrolled runoff volume. Therefore, it was thought that drainage line and the tank area is connected through an underground pipe line buried 30 cm below soil surface. For this purpose, the neighbouring farmer was also requested and convinced to cooperate. Thankfully, he readily agreed upon and granted permission to divert the runoff water through underground pipes passing through his field. Thus, two 8" diameters PVC pipe was buried to carry excess runoff from the drainage line to tank area. Beyond this junction portion of the drainage line and pipe, a loose bolder structure at 2 meter away from the pipe opening was constructed so that the runoff velocity is reduced and diverted towards the pipe opening without disturbing the natural drainage of the drain line. Thus, the provision of the underground pipe increased the chances of providing additional runoff water from the other neighbouring farmers' cultivated areas during monsoon season. This work was completed in the month of May 2011. For installation of the pipe and construction of loose boulder structure, the farmer incurred ₹ 80000/- for this purpose. Thus, with the efforts and technical guidance of the project team, a huge water harvesting tank of size 85 m x 85 m x 10 m was available with the farmer to be used as water storage tank of 60000 cu.m. with investment of 80000/-.
